DEPARTMENT OF TRANSPORTATION

Contract #: 04-0120F4Cty: SF/ALA Rte: 80 PM: 13.2/13.9File #: 69.28**WELDING INSPECTION REPORT****Resident Engineer:**Pursell, Gary**Address:** 333 Burma Road**City:** Oakland, CA 94607**Report No:** WIR-015404**Date Inspected:** 28-Jun-2010**Project Name:** SAS Superstructure**OSM Arrival Time:** 700**Prime Contractor:** American Bridge/Fluor Enterprises, a JV**OSM Departure Time:** 1900**Contractor:** Zhenhua Port Machinery Company, Ltd (ZPMC), Changxing Island **Location:** Shanghai, China**CWI Name:** Wuzhi Cheng**CWI Present:** Yes No**Inspected CWI report:** Yes No N/A**Rod Oven in Use:** Yes No N/A**Electrode to specification:** Yes No N/A**Weld Procedures Followed:** Yes No N/A**Qualified Welders:** Yes No N/A**Verified Joint Fit-up:** Yes No N/A**Approved Drawings:** Yes No N/A**Approved WPS:** Yes No N/A**Delayed / Cancelled:** Yes No N/A**Bridge No:** 34-0006**Component:** OBG Segment**Summary of Items Observed:**

OBG # TRIAL ASSEMBLY YARD

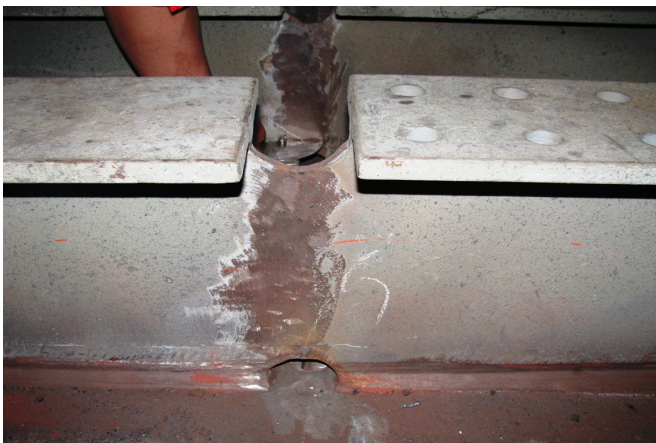
9AE-9BE (PP 73 – PP 74)

This QA inspector measured and recorded offset between below segment for T-Rib (Web and Flange) along with ABF and ZPMC. The measurements are recorded in the designated sheet and forwarded to team leader for further action.
